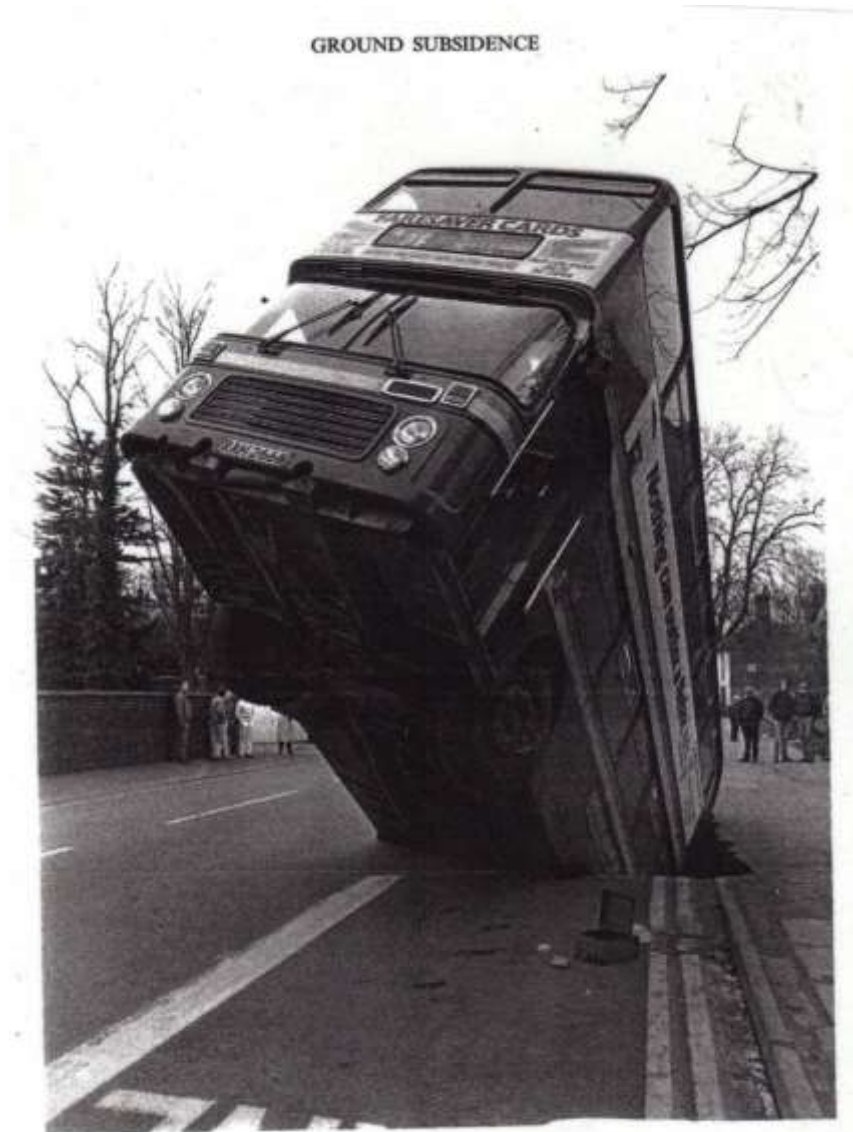
Figure 1.1 A bus caught at an unusual angle when a road collapsed beneath it early in 1988 in the city of Norwich. The subsidence was due to failure of weathered chalk above old abandoned mines (Photo: Eastern Counties Newspapers).

Suggest a geological process which might have caused this.
